Week 11 and 12

Overview of the Work Completed

- a. Manufacturing of the Rotary Motion Module
- b. Testing of the Rotary Motion Module
- c. Manufacturing of the Spindle Mount, Base
- d. Prediction of Tool Point Error using Error Budget Spreadsheet
- e. Assembly and Test of Lathe

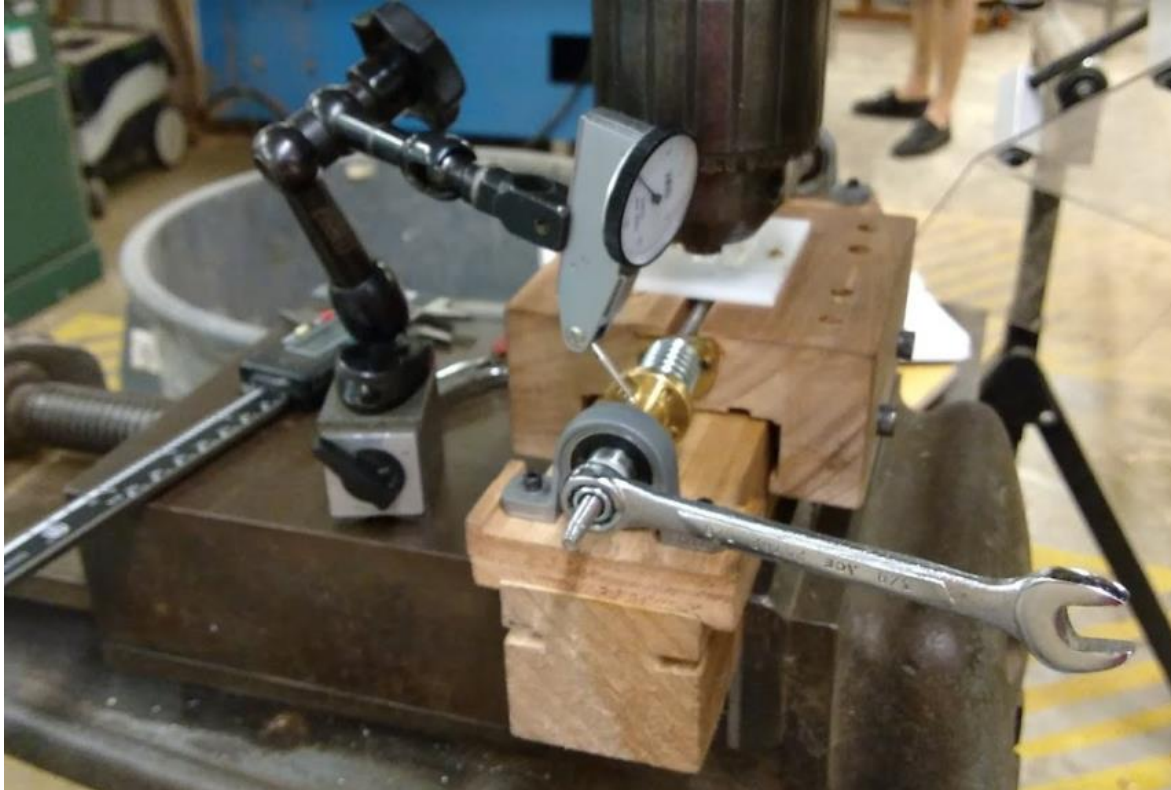
Attempt to measure the runout of the Leadscrew

Procedure: An attempt was made to measure the runout of the leadscrew by inserting a nut on the leadscrew. However, during measurement, it was found that the surface of the nut was uneven and the measurement that I was making involved significant component of the error from the nut itself.

I thought of subtracting the curvature of the nut from my measured values to get the runout of the leadscrew. However, the method did not give me significant results.

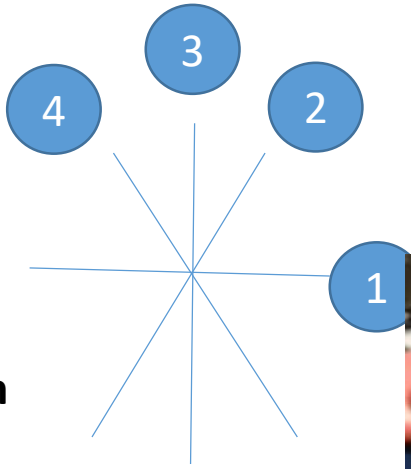
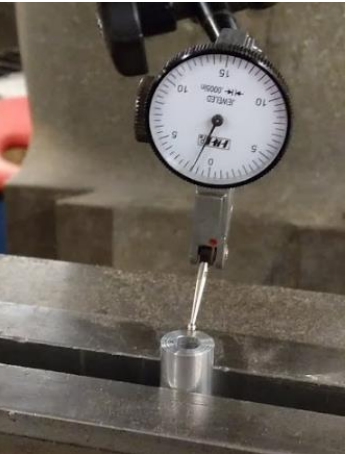
Profile of the cut workpiece is similar to this:

Lesser value of the critical dimension at the edges and higher near the center

Predicted Error in the sensitive direction as per error budget sheet = **108 microns**

Error measured on the part = 6 divisions = **76.2 microns**

Sr. No	Distance	1	2	3	4
1	0.4 mm	-2	0	1	1
2	0.8 mm	-1	1	0	0
3	1.2 mm	-1	2	0	0
4	1.6 mm	0	2	2	0
5	9.2 mm	-3	1	0	-4
6	9.6 mm	-3	1	-4	-4
7	10 mm	-3	0	-4	-5
8	10.4 mm	-4	0	-4	-6
9	10.8 mm	-4	-1	-4	-9

Average Deviation = 6 divisions = 76.2 um
